Draft Earthquake Contingency Plan Ward 8, Rangamati Municipality

BUET-Japan Institute of Disaster Prevention and Urban Safety (BUET-JIDPUS)
Department of Urban and Regional Planning
Department of Civil Engineering
Bangladesh University of Engineering and Technology (BUET),
Dhaka-1000, Bangladesh.

March, 2021

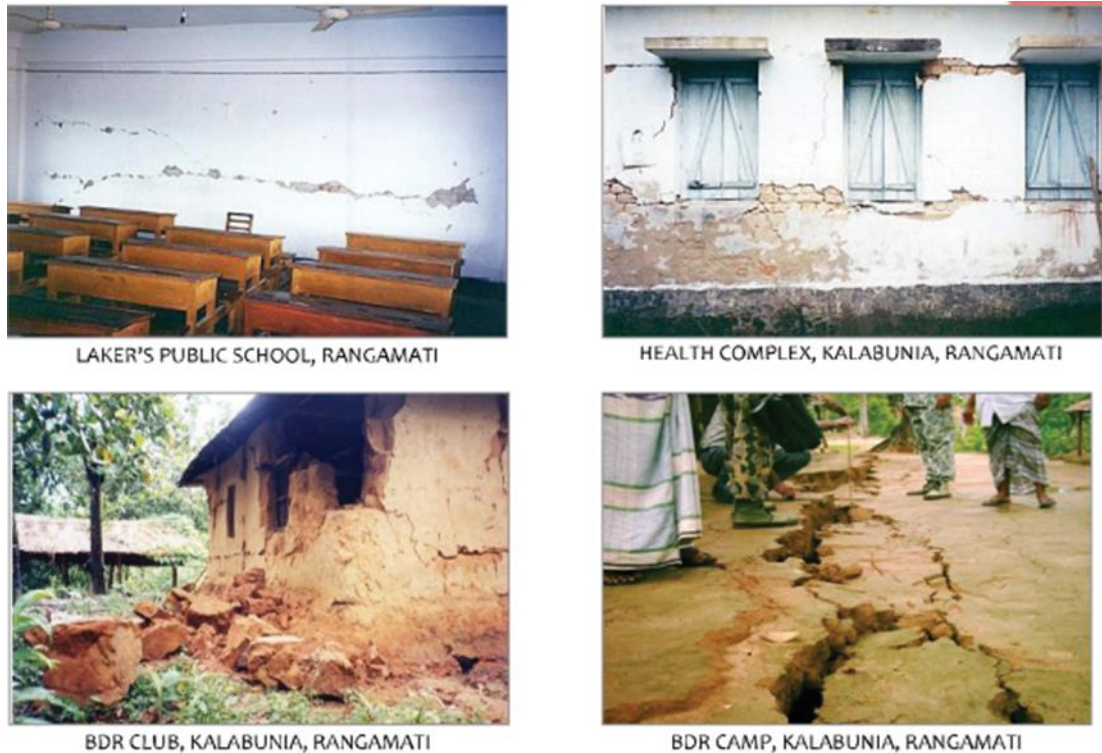
Figure 1.4: Damage of earthquake in Kolbunai, Rangamati after 2003 earthquake

Rangamati faced a severe earthquake of magnitude 5.1 in 27 July 2003 at Barkal Upazila of the district. Its origin was at 28 km northwest of Rangamati district. Three people were killed, 25 were injured, and hundreds of buildings of Chattogram and the surrounding hilly area were damaged. Many katcha and pucca structure showed crack,

even earthen ground was ruptured in some place of Kolabunia union. Two to three kilometres of Karnafuli riverbank was demolished (Figure: 1.4).

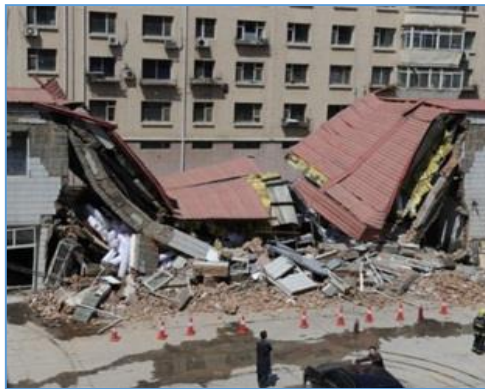
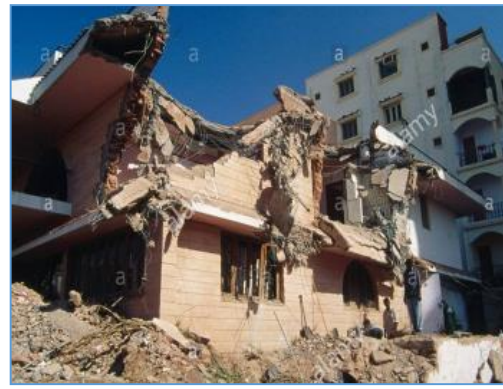
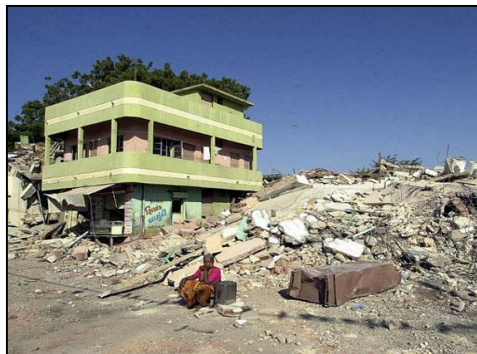
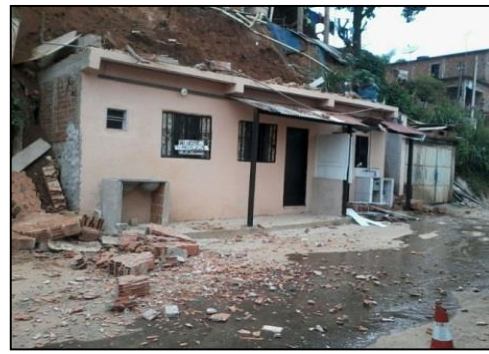
(a) URM buildings (Bhuj Earthquake 2001, India (Dinodia Photos RM, 2001))

(b) RCC buildings (Bhuj Earthquakes 2001, India (Datta, 2001))

Figure 3.9: No block conditions

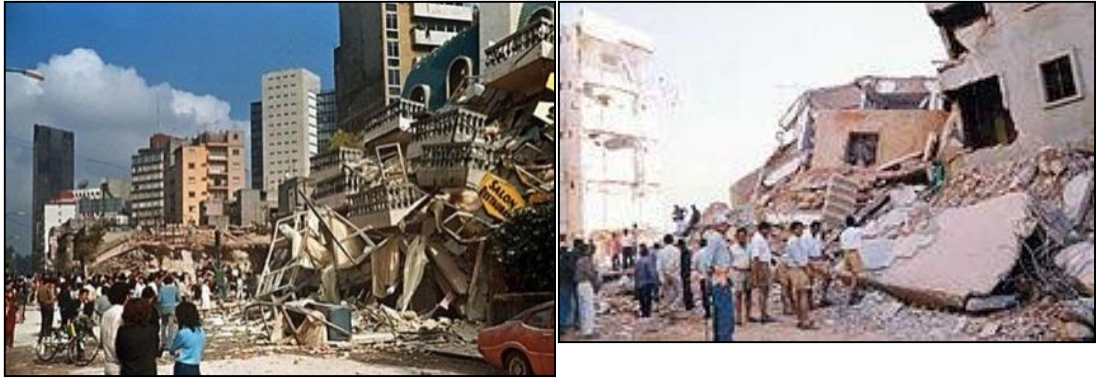
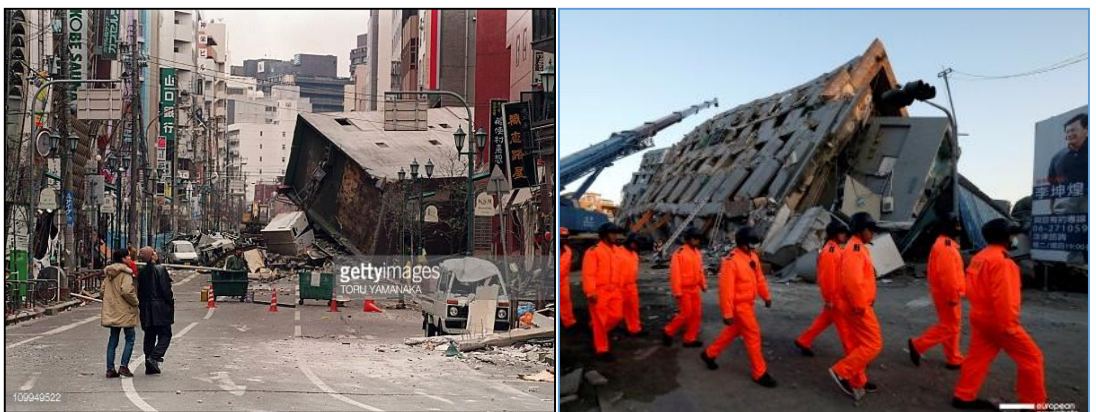
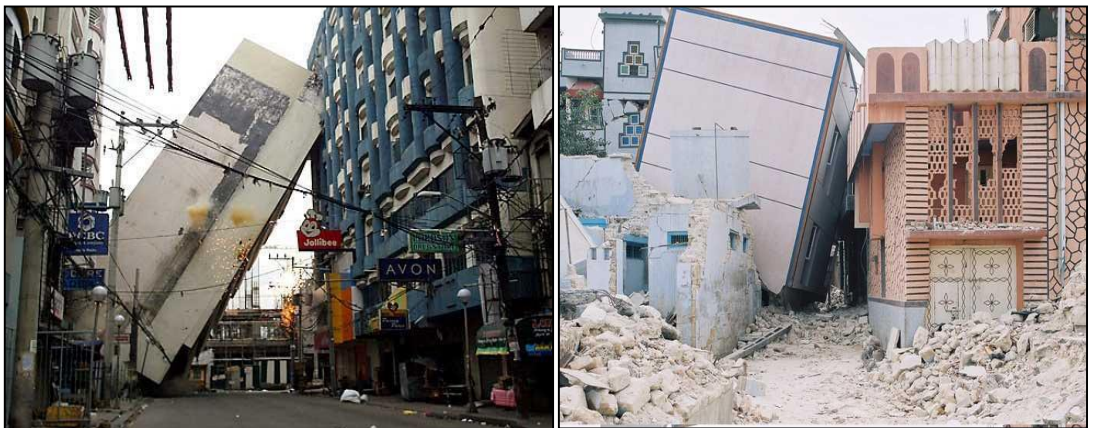
(a) URM buildings (Bhuj Earthquakes 2001, India (Singhania, 2016))

(b) RCC building first condition (Great Hanshin Earthquake 1995, Japan (Yamanaka, 1995))

(c) RCC building second condition (Bhuj Earthquakes 2001, India (Langenbach, 2001))

Figure 3.10: Partial block conditions

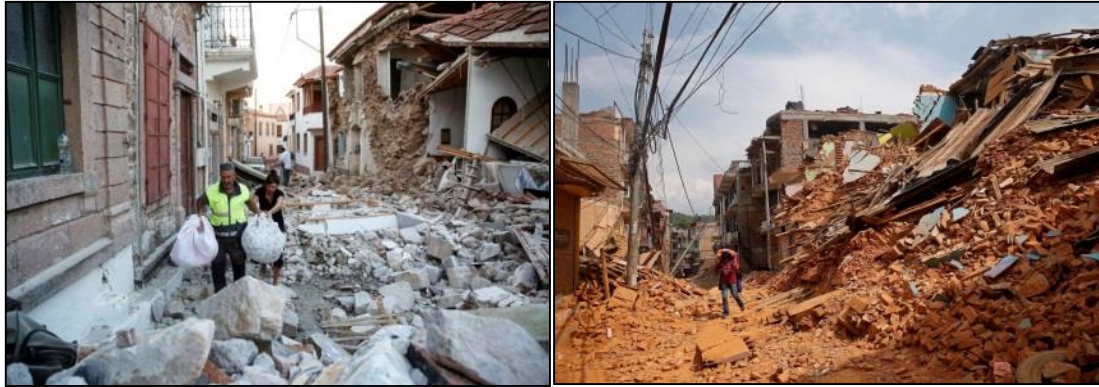
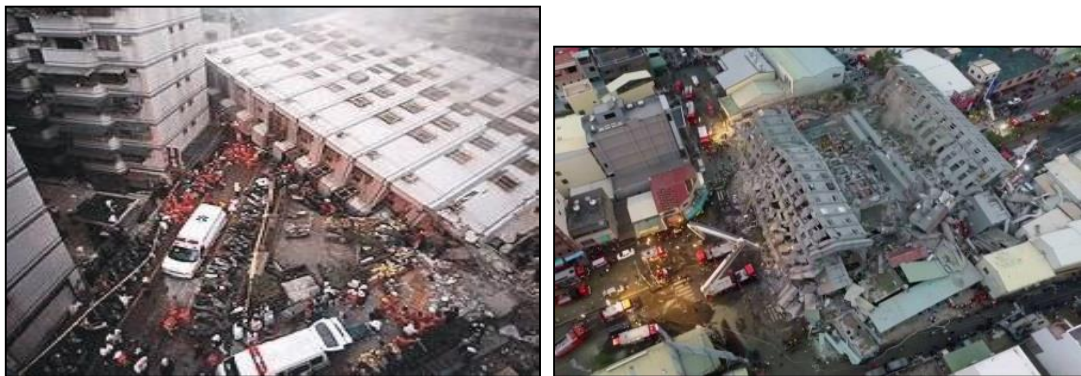
(a) URM buildings (Nepal earthquake, 2015 (Masood, 2015))

(b) RCC buildings (Taiwan earthquake, 2016 (NDTV, 2016))

Figure 3.11: Full block conditions

- Vulnerable URM building four storied or more: If the building height is greater than or equal to the width of front road, then it will fully block the road in front of it (Figure 3.11a).
- Vulnerable RCC building four storied or more: If the building height is greater than or equal to the width of front road, and there is either no building or semi pucca or katcha or one storied safe pucca or one storied or multi storied vulnerable building on the opposite side of the road, then it will fully block the road in front of it (Figure 3.11b).

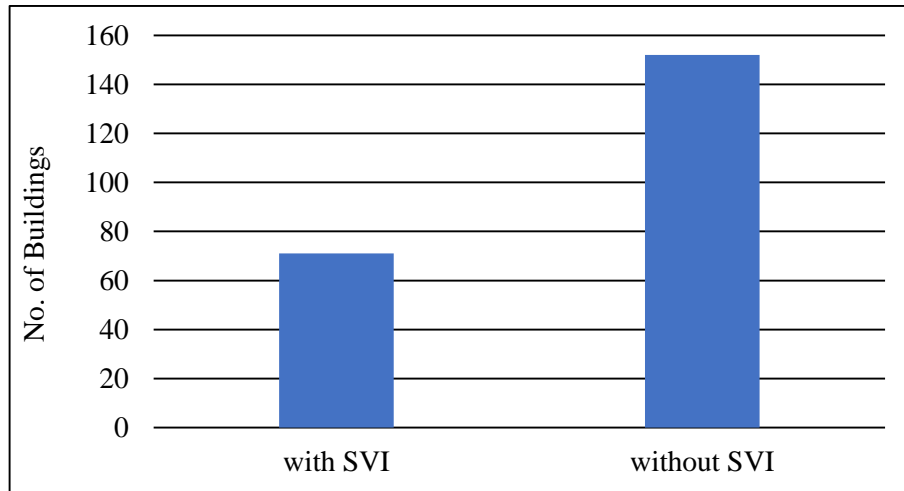
Figure 5.5: Relations between number of buildings and severe vertical irregularity

Figure 5.6 represents relation between number of buildings and severe vertical irregularity which include any or a combination of the following: short column, soft story/weak story and out of plane setback. It has been observed that 32% of the buildings that were surveyed have severe vertical irregularity.

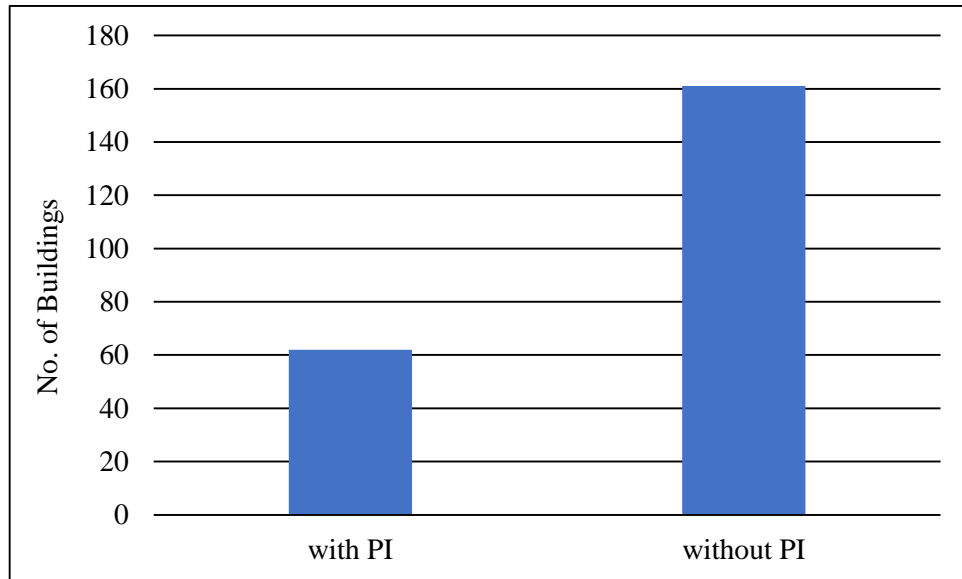
Figure 5.7: Relations between number of buildings and plane irregularity
